Abstract submission:

Test Method for Water Penetration and Leakage Through Masonry Wall Construction

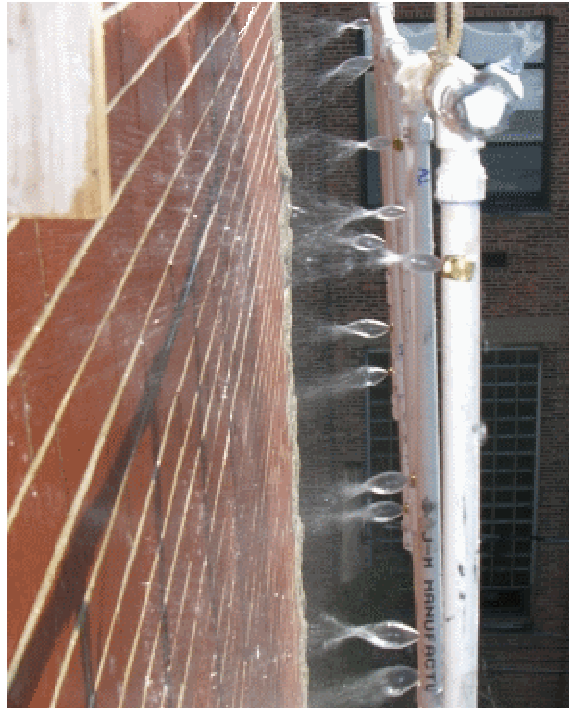
Spray rack on exterior face of masonry wall

A spray rack, as used in *ASTM E1105 Standard Test Method for Field Determination of Water Penetration of Installed Exterior Windows, Curtain Walls and Doors by Uniform or Static Air Pressure Difference* is placed on the exterior surface of the masonry wall using the same rack placement (1 foot away) and the same delivery rate (5 gal/sf/hour), however a pressurized chamber is not used.

Since water from the spray rack will run down the wall beneath the spray rack, the area beneath the spray rack can be considered to be within the test area so long as that area is no greater in height than 1.5 times the spray rack itself.

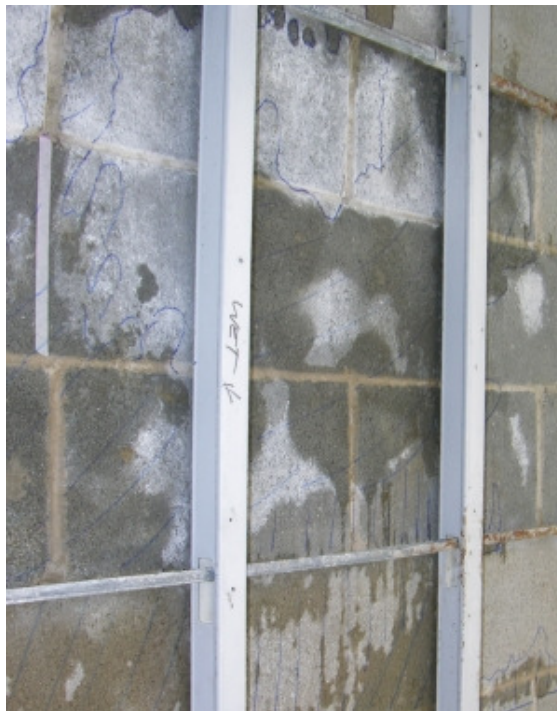
Interior view of the results of the masonry water spray test

The exposed interior surface of the masonry wall construction is observed during the test.

Locations where leaks are observed are outlined with marker and identified with the number of minutes that elapsed from start of test until the time the outline was drawn.

If the leak grows, another outline can be redrawn and marked with the updated duration, so that a record of the progression of the leak can be made.

At the end of the test, these outlines are photographed and included with the test results. The test report can also include an estimate of the percentage of wall surface which was wet at the end of the test.
